# CRYL-A-FLEX

**Product:** Cryl-A-Wall VC  
**Customer:** Connecticut DOT  
**Industry:** Municipality  
**Date:** November 2005

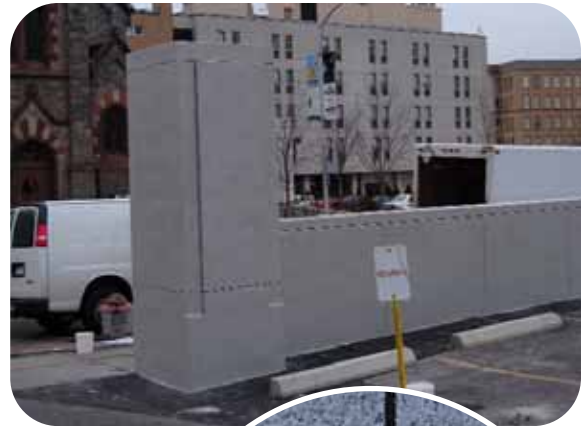
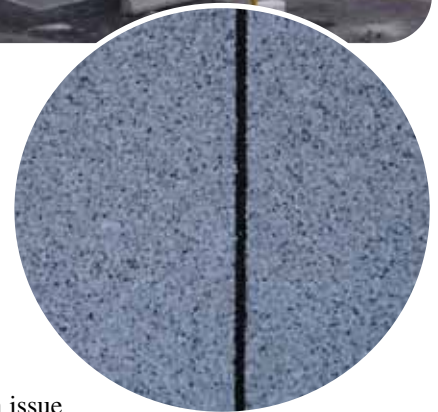
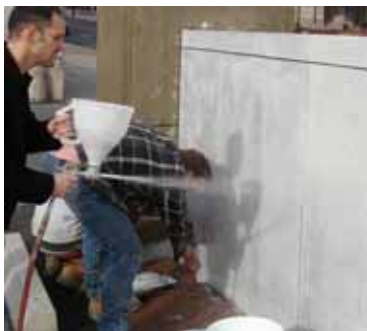
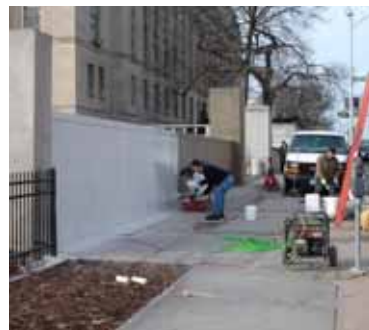
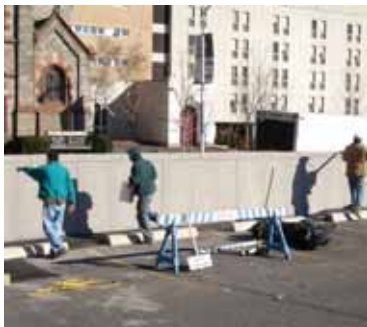
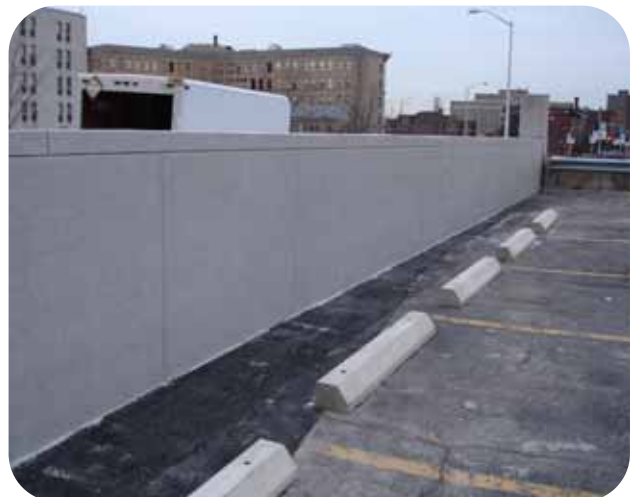
The granite veneer on a concrete wall (150 feet long x 10-15 feet high) had deteriorated, was separating from the concrete and therefore becoming a safety hazard. The deterioration was from water getting behind the veneer and years of freeze/thaw that had not only separated the veneer but also deteriorated the concrete beyond repair. It was therefore necessary to demolish the existing wall, and erect a new wall to appear to be made of granite but more economically.

The answer to all the issues was to pour a new concrete reinforced wall and then apply the Cryl-A-Wall VC system from Dur-A-Flex. The system was applied using the Shale Micro Chip blend that was a very close match to the remove granite. Another potential problem could have been the temperature as the Cryl-A-Wall VC was applied when the

temperature was 35 F. The temperature was not an issue because the Cryl-A-Wall VC system is based on MMA.

Methyl methacrylate resin can be applied at temperature below freezing and still achieve a full cure in one hour.
