CRYL-A-FLEX Applications

Product: Cryl-A-Quartz, Cryl-A-Tex
Customer: Saltgrass Steakhouse, Houston, TX
Industry: Restaurant
Date: September 1999

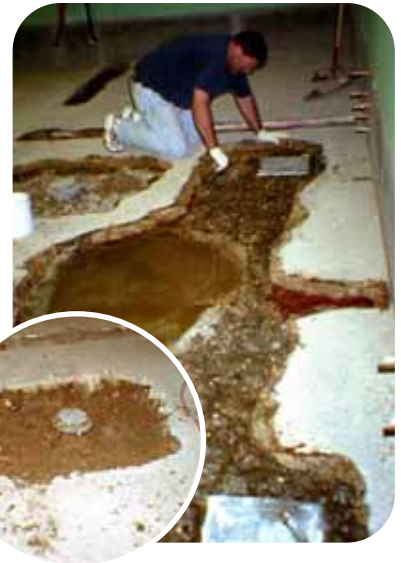
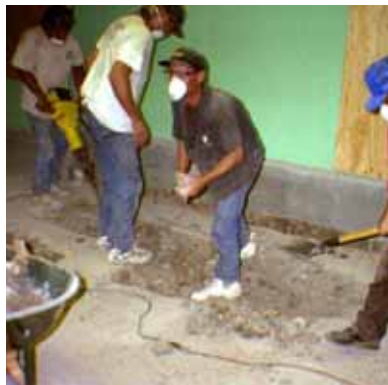
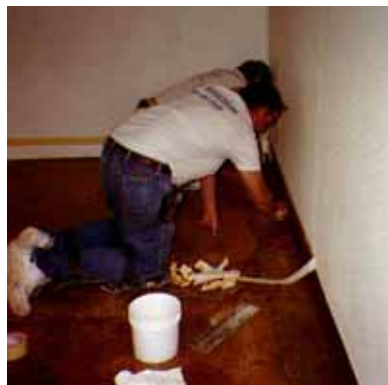
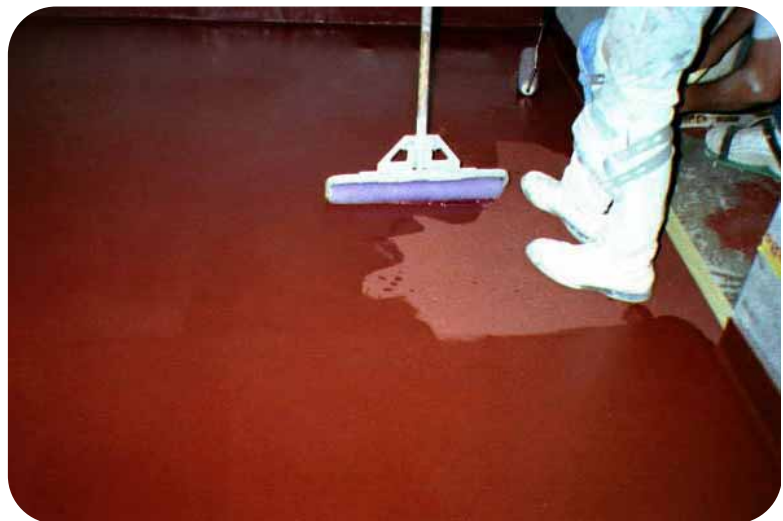
This project involved a total re-model of the 2,300 SF kitchen and bar area. The problem is that there are only 7 days to accomplish the work that includes demolition of walls, adding drains, removal and installation of equipment. As there is other trades during the day, the work to the floor could only be done at night.

The floor rehabilitation begins with the repair of the substrate. This involved 500 SF of 4-6 inch deep repair of deteriorated substrate and patching around new drains. This is done with Cryl-A-Tex (MMA) polymer concrete. The next step is to prepare and prime the concrete with Cryl-A-Prime P-101. The following evening the MMA coves and the double broadcast Cryl-A-Quartz is installed in the dry

storage area. The last evening the floor is installed in the kitchen and bar area. With a very tight construction schedule, Cryl-A-Flex's fast cure enabled the work be accomplished over night. The 1-hour cure gives the other trades a fully cured floor every morning. Another benefit of the Cryl-A-Flex system is its ability to always bond to itself. There is never the fear of a cold joint between layer of the system.

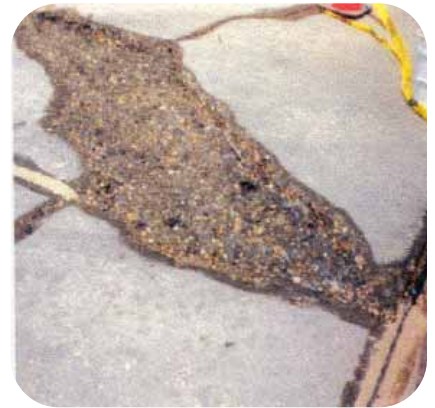
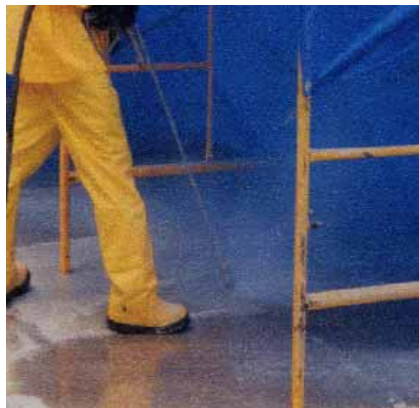
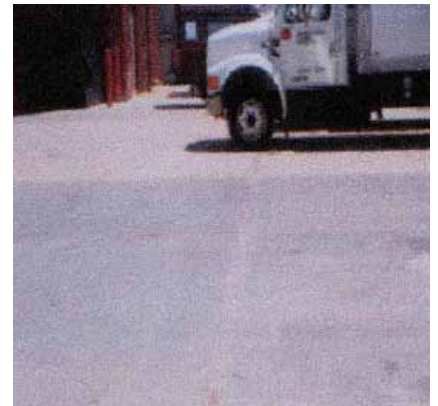
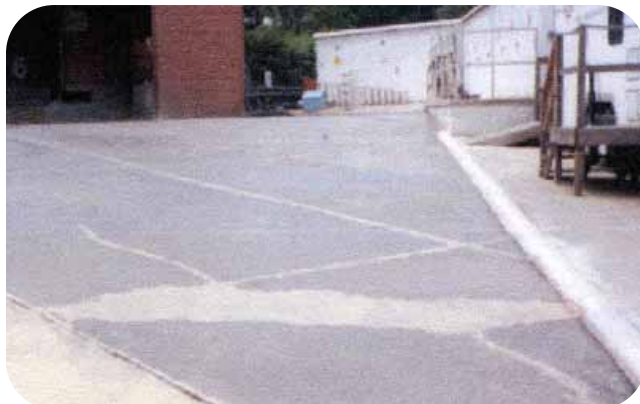
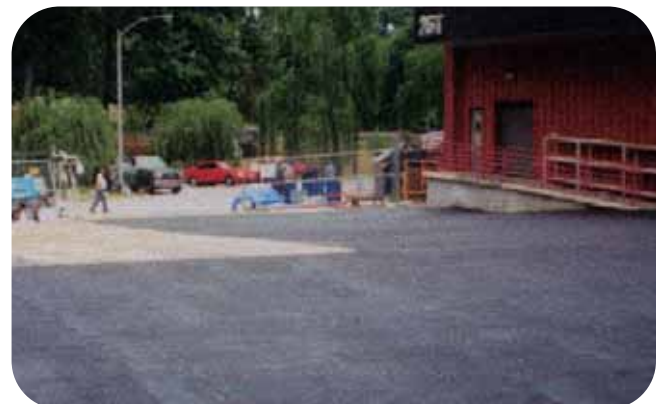
The problem at this facility is the 13,000 SF concrete driveway and loading dock area at the radioactive waste recovery building. The concern is that in the event of a spill the area would not be contained. There are problems with cracked and spalled concrete and 1,725 LF of joints that had been improperly repaired. A material is required that will function for containment, cure quickly (the work is to be done on a weekend) and be suitable for an outdoor environment.

It is determined that the Cryl-A-Flex (MMA) will meet all the criteria. The first step is to remove existing caulk and all loose material from the joints. The best way to accomplish this is with water blasting. 120 Cu. Ft. of Cryl-A-Tex polymer concrete is used to patch and rebuild the joints. The area is then prepared by shot blasting and a double broadcast of Cryl-A-Quartz (Q 11) system with a single top-coat is installed.

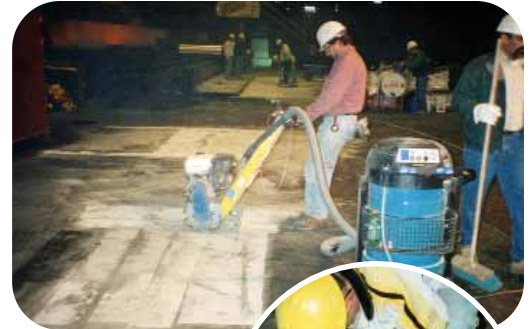
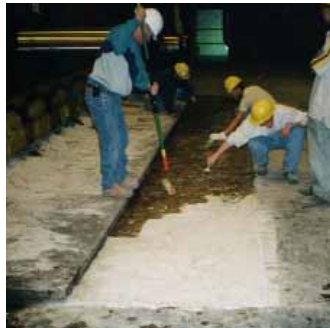
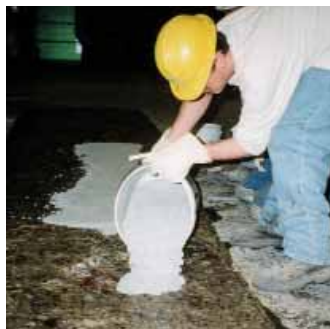
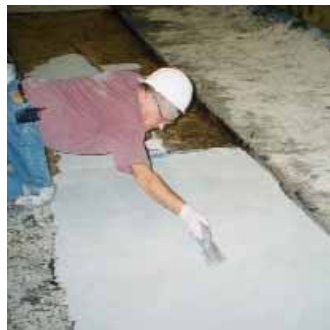
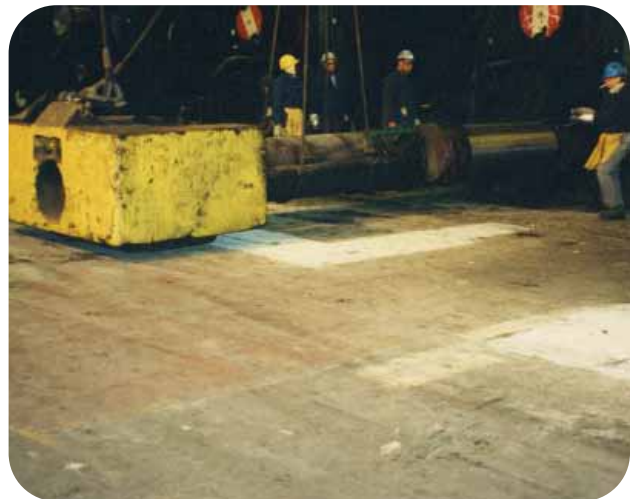
The concrete floor is badly deteriorated due to heavy traffic and impact damage as the result of the 10-ton counter weight of the roll changer hitting the floor. The problem has escalated to where the damage to the concrete is from 1-6 inches deep. This damage is created a safety issue for the workers. The challenge is to fix the floor and not interfere with the continuous operation of the mill.

A material is required that can be used in a wide range of repairs, 1-6 inches deep and cure to full strength in 1 hour. There is typically only a 5-hour window between roll changes, so preparation, application and cure of the material has to be quick. The answer is the Cryl-A-Tex (MMA) polymer concrete system. The 2 component system can be used as a mortar up to 1/2 inch thick.

For greater depths it is extended with clean/dry pea gravel. The size and amount of gravel that is used

is a function of the depth of the repair. For the 6-inch deep repairs 45 LBS of 3/4 inch pea gravel is added to the 35 LBS of Cryl-A-Tex mortar. The result is a cost-effective material that is installed in one lift.

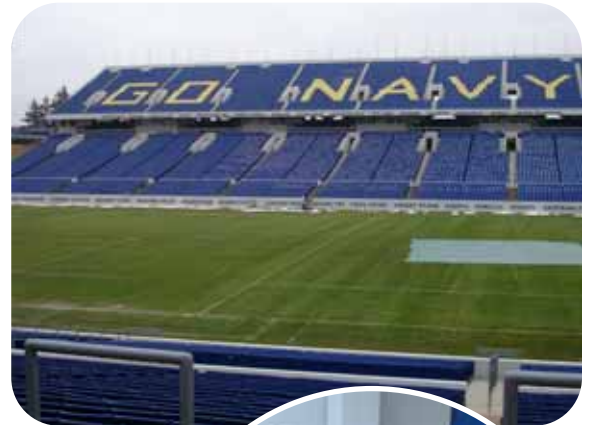
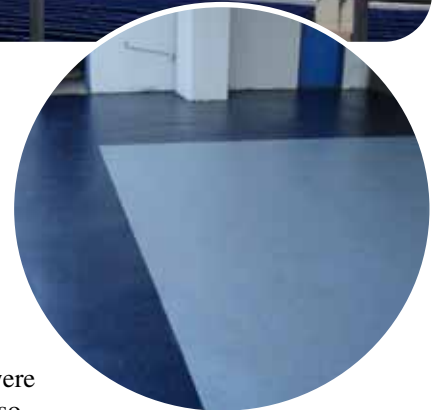
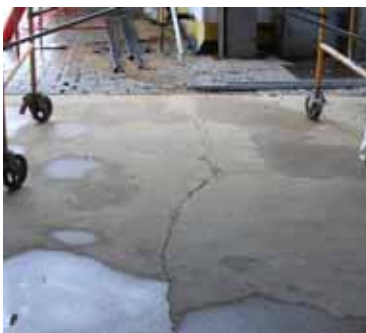
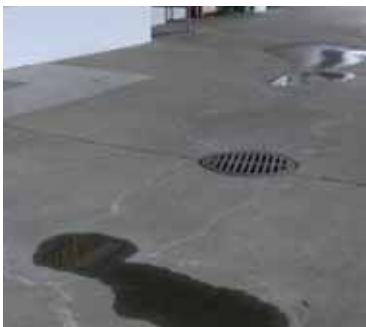
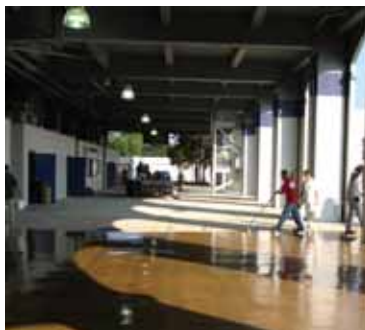
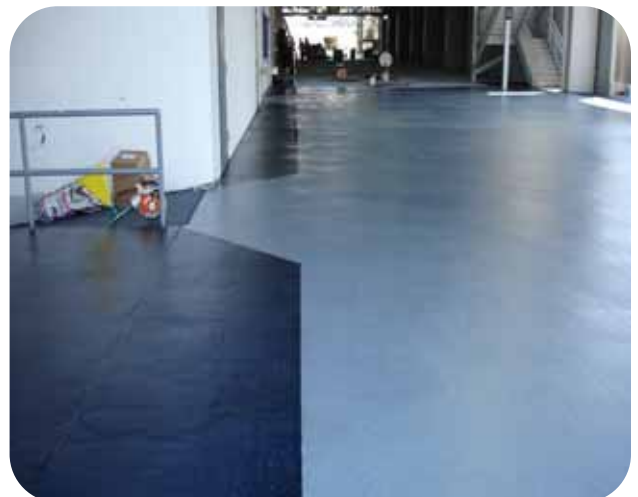
The concrete surface (40,000 SF) under the stadium seating, which is exposed to weather, had deteriorated over the years. The concrete had cracked, pot holes had formed and the joint edges have broken away. This area also included the bathrooms and concession stands. The pathways from this area, under the stands to the seating area, which are steep, were also worn. The area is in need of a major face lift and resurfaced for safety reasons.

A versatile product was necessary as it had to be resistant to a wide range of chemicals from those used in a bathroom, de-icing salts, UV resistant, anti-slip and aesthetic finish product. The system that met all the criteria was the MMA based material systems from Dur-A-Flex. Some special shades of blue quartz were used to match the Navy colors. The texture was also designed to meet the requirements of the area in which it was installed. The quick cure of the MMA also allowed the project to be completed in the required construction schedule.

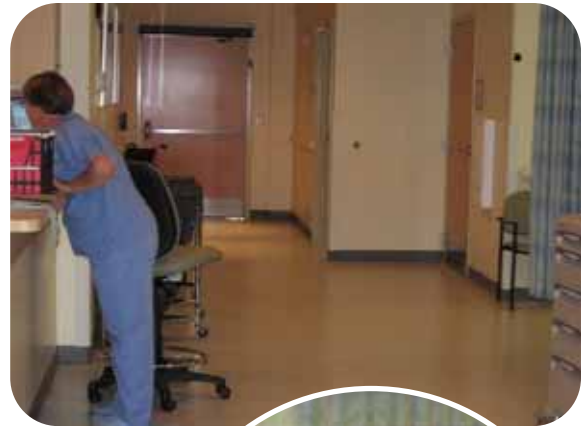
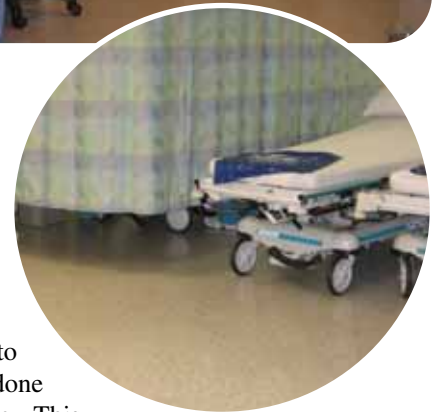
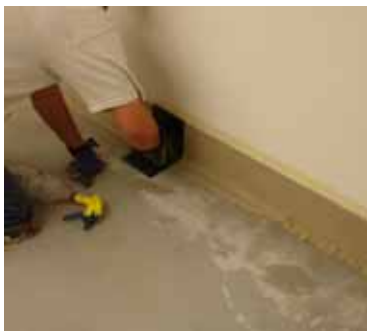
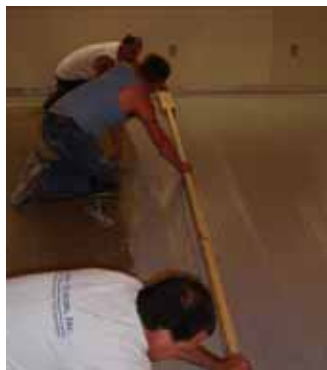
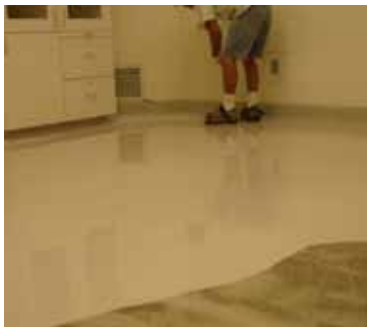
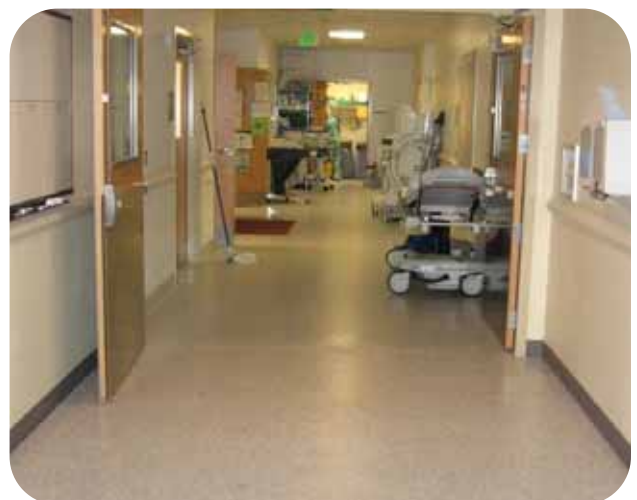
After the owner had moved into their newly built facility they discovered that they had a major problem with the concrete. Specifically the floor was not flat. It was actually so bad that if left unattended a gurney or wheel chair would roll across the room. A survey of the floor flatness revealed that in some of the rooms the floor had a difference in elevation of over 2.5 inches. There was approximately 6,200 SF of floor that had to be leveled and 600 feet of cove to be installed. And of course the floor had to be fixed with as short of shut down as possible.

It was determined that the fastest way to get the problem rectified and get the facility back into operation was with the use of Dur-A-Flex's MMA based materials. First the high spots in the building had to be located. Then a laser was used to set new elevations to which the floor was leveled to. The leveling was done with Cryl-A-Tex, an MMA based polymer concrete. This material cures in one hour. The owners wanted a floor that would be seamless, low maintenance, and work in a hospital environment. It was determined that a 3/16 inch thick Cryl-A-Chip SL floor would be the perfect solution. This system also meets all the USDA/FDA requirements and is NSF registered.

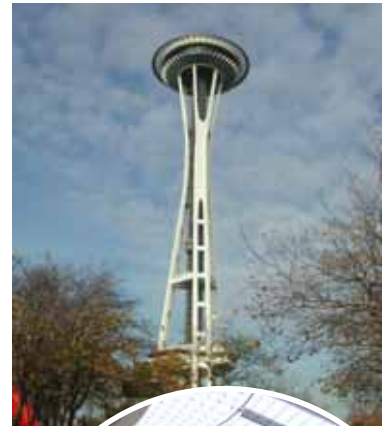
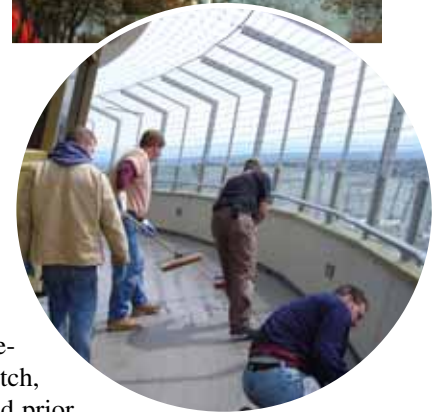
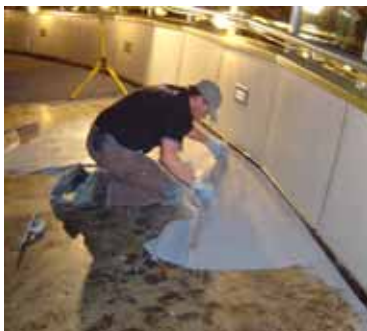
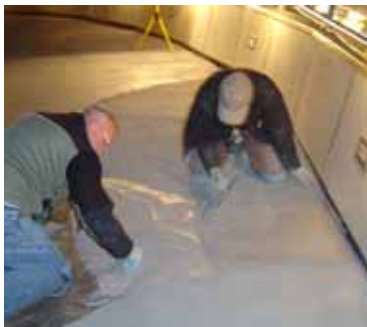
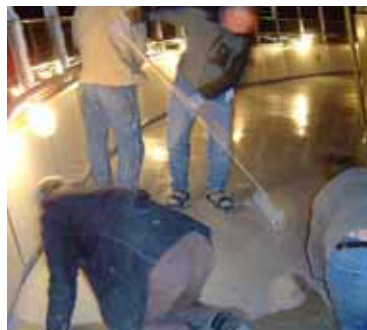
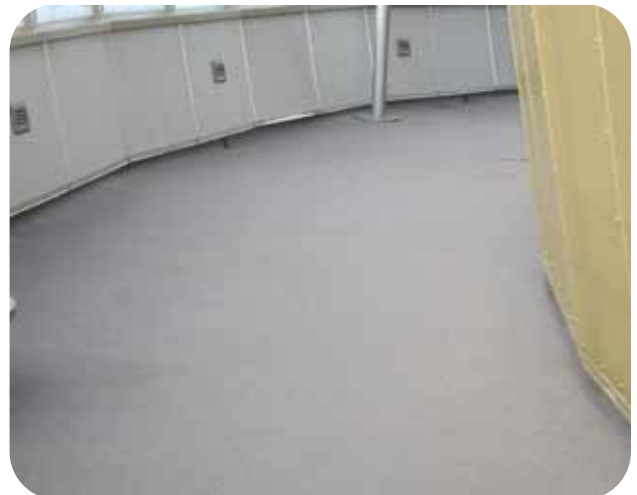
Every four years, the floor in the Observation Deck had to be repaired. The owners looked at the life cycle costs and realized that they had to come up with a better solution to fit their business needs. The floor was being repaired so often because the membrane had failed, there were problems with spalled concrete and, water was leaking into the Restaurant below. The challenge was to do the restoration to the Observation Deck with no interruption to the in the operating schedule.

Dur-A-Flex's MMA based Cryl-A-Quartz SL was the system that could be used because this material cures to full strength in one hour and can be used in an outdoor environment. The work was done through the night when the facility was closed and finished each day in time to open for normal business hours. When the old deck was removed they found that the original material to slope and pitch the deck to the drains was far more deteriorated than anticipated. To facilitate the correct pitch, Cryl-A-Tex (MMA) polymer concrete was installed prior to the installation of the floor system.

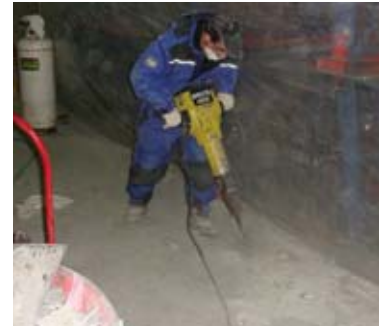
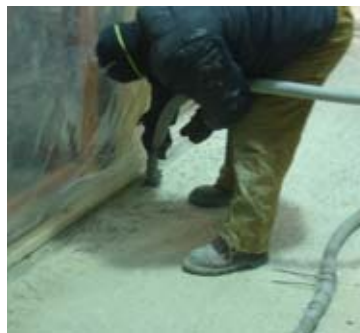
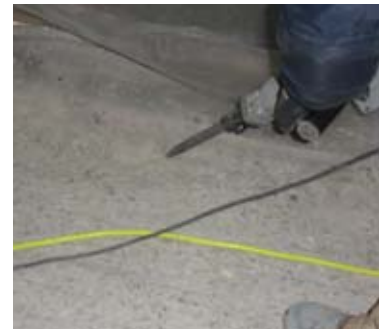
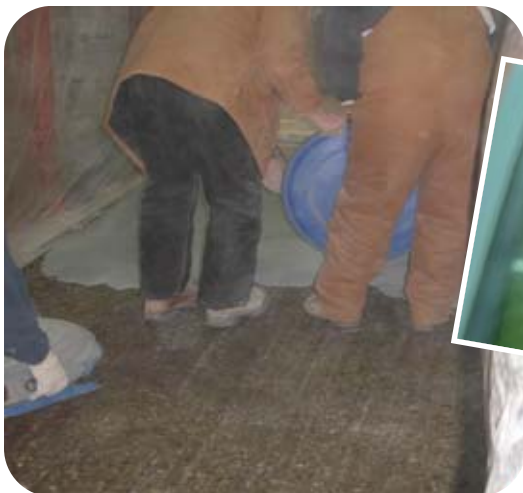
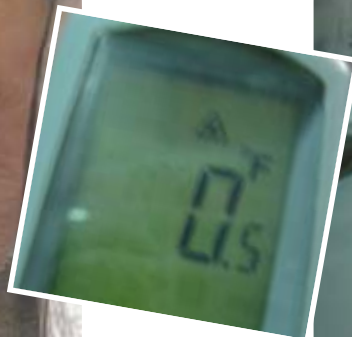
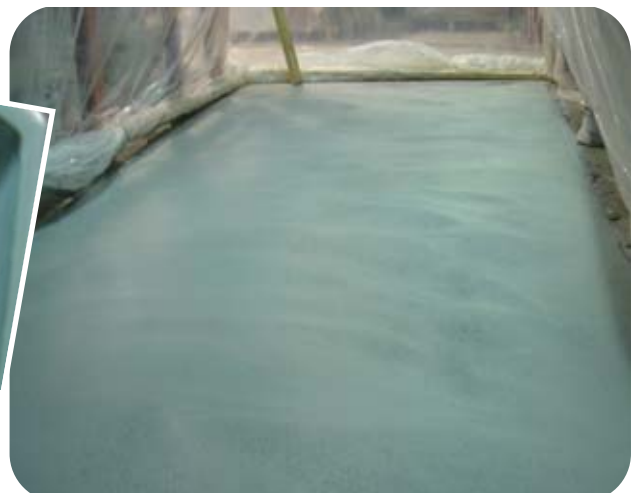
The aisles in the freezer floor had deteriorated to a point that made them a safety issue by creating excessive damage to fork lifts and damaging product. Attempts had been made over the years to patch the floor with various products with very limited success. How would they be able to repair a floor that is at 0°F over a week-end and not interfere with the warehouse operation?

The contractor knew that the only solution was Cryl-A-Tex polymer concrete from Dur-A-Flex, Inc. Since this MMA based system is capable of being installed in temperatures as low as -20°F, 0°F was not a concern. A 250 SF sample was installed 6 months prior to the larger application of 900 SF so that the customer could be assured of a successful application. The project involved removing ½ inch of failed topping, and installing tenting to control dust and to achieve the necessary ventilation for the material application. The demolition was more extensive than anticipated because they had to remove concrete up to 2 inches deep. Once the area was cleaned and all loose concrete removed, the surface was primed with Dur-A-Flex's Cryl-A-Prime P-101, which took 1 hour and 15 minutes to cure. The deep holes were then filled with Cryl-A-Tex that was extended with dry pea gravel. This again took about 1 hour and 15 minutes to completely cure. The patches were re-primed and the ½ overlay of Cryl-A-Tex was installed. The work was completed; the area was cleaned up and ready for operation on Sunday evening.
